# **Examination of Damage Processes of Orthopaedic Orthosis**

#### Abstract

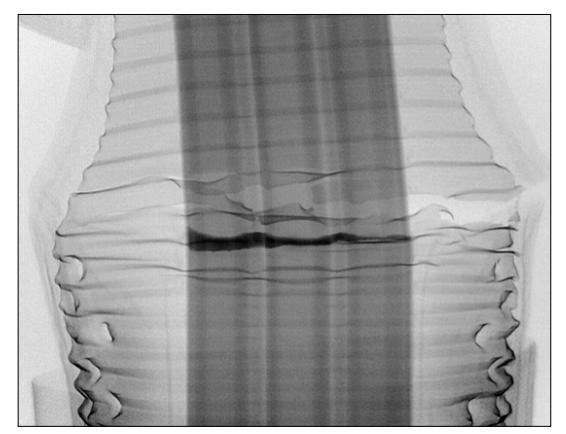
The product, illustrated in **Figure 1** was assembled from two types of plate (thickness 0.2 mm and 1.1 mm) with rivet fixation. The thinner plate provides the bending onto the arm and the thicker plate is responsible for the actual fixing. The X-ray microscope image immediately showed that the product was broken at the height of the wrist, across its entire width. On the device investigated, the distinct fracture only affected the thicker reinforcement plate, which was 1.1 mm thick. The thin corrugated aluminium, 0.2 mm thick plate, was only partially broken under load, or in the case of the stressed device, not broken at all (**Figure2**).

From this property, it can be inferred that the thicker the reinforcing plate, the more rigid it behaves and therefore is less resistant to fatigue.

Figure 2. X-ray of the fractured part of the wrists of the palmar forearm.

A higher magnification image, examined with a stereomicroscope, shows that this fracture is not a pure fatigue fracture. In the second phase of the fracture, static rupture may have been involved in the fracture process.

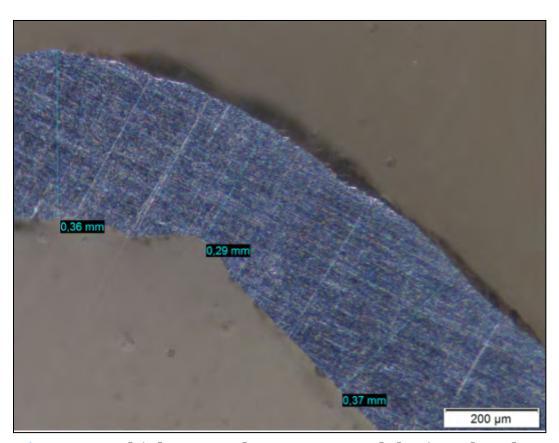
To test the corrugated aluminium sheet in the orthoses, I made a resin embedded abrasive from a piece of factory corrugated aluminium strip, Lot: 76, 0.4 mm thick. The first striking observation I made was that even at low magnification it was possible to see that the profile of the corrugated aluminium sheet was not symmetrical, i.e. not sinusoidal.

The aluminium profile has unexpected indentations. Since this phenomenon is seen in the same part for all corrugations, I conclude that there is a bulge or a machining defect in the corrugating tool. The aluminium is 7-8  $\mu$ m thinner in the chipped areas than in other areas (Figure 3). These spalls and thins act as stress accumulation sites. These areas are more likely to develop cracks and subsequent fractures. A small depression runs longitudinally along the bottom of the corrugations. This depression is present on all the corrugations, so I conclude that there is some kind of tooling defect along the entire length of the corrugator.

Figure 3. Thickness values measured during the plate profile test.

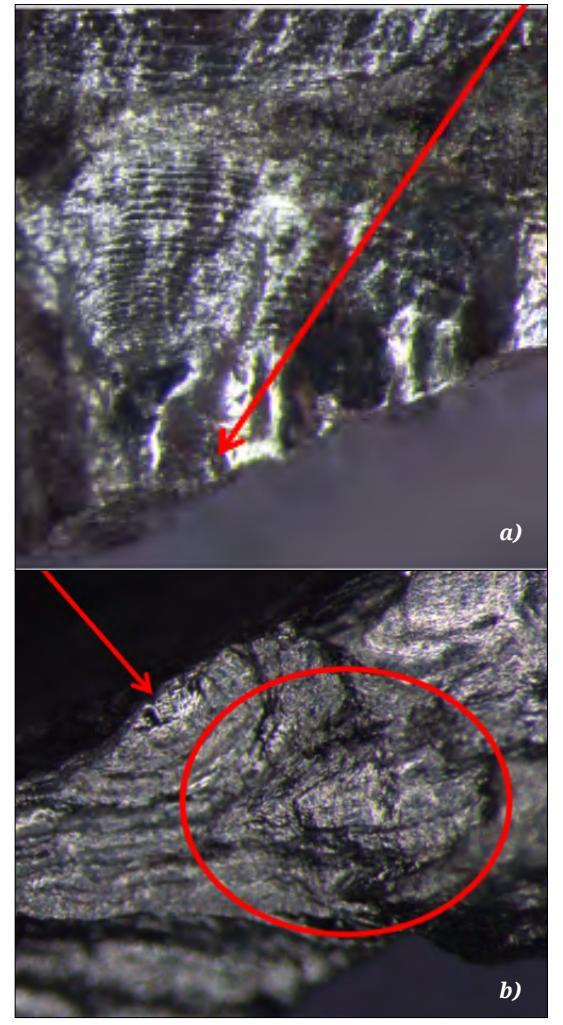
Both figures above clearly show semicircular grooves growing away from the crack initiation point. In the case of the fatigued device, the fatigue frequency was probably higher than in the case of the investigated rail, resulting in the formation of several grooves closer together. In the case of the investigated device, the grooves are spaced further apart.

Once the crack reaches a critical size, the propagation becomes unstable and the piece then breaks due to some static fracture. The pointed convexities that are visible in the circled part of **Figure 5** b) have undergone plastic deformation in the compressive half-cycles, dulling down

Figure 5. (a) Crack initiation site on the proximal burst surface of the fatigued and the investigated (b) orthosis, marked with an arrow.

and losing their original fractographic features. It is interesting to note that in the case of the fatigued tool, cracks were so densely formed as a result of the regular cyclicity that sometimes the semicircular grooves, starting from several directions, overlap. The resistance to fatigue can be improved by mechanical (rolling, spraying) or thermochemical hardening (nitriding) of the surface layer, or by surface coating (e.g. PVD). In the factory, the application of a polychromic coating to aluminium sheet is not considered as heat treatment.

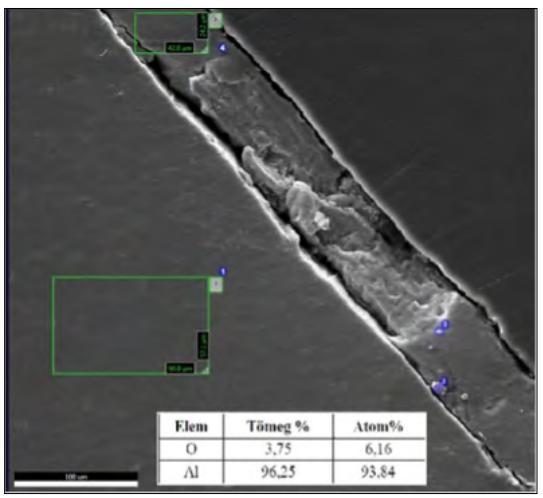
Figure 6. Scanning electron microscope image of a part of the sample and the composition of the material measured by EDS in tabular form.

10 mm. From the images taken, it was found that there were no inclusions, foreign material, cracks or breaks in the plate. That is, the material of the plate can be considered homogeneous. The material of the stiffener plate was also examined by energy dispersive X-ray spectrometry (EDS).

The measurement proved that the plate contains only aluminium, since the oxygen peak can be considered as an artificial product caused by molecules adhering to the surface: in this case, too, it is found in the sample due to contact with air.
