Application of 3PHV60 Type Epoxy Resin for the Repair of Timber Structures

Péter MÁRTON

Abstract

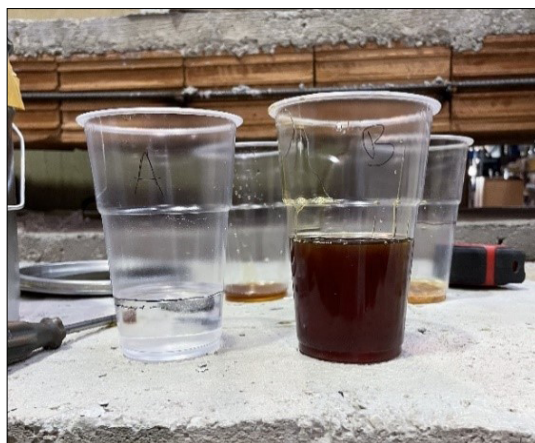
Fig.1. The „A” and „B” components of 3P resin.

The production of 3P resin starts with a simple but careful mixing of components A and B. The

two components are homogenised in a volume ratio of 1:2 (Figure 1).

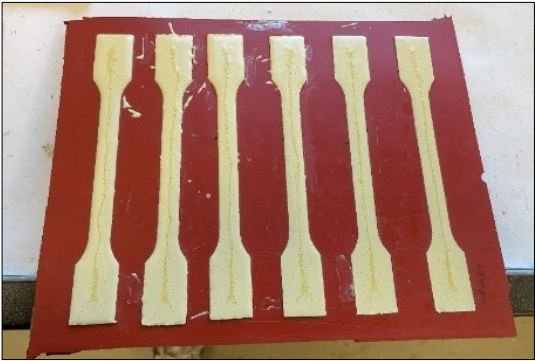
Fig. 2. Test specimens used to determine the tensile strength of the resin.

I used a mould to produce the specimens used to determine the tensile strength of the resin. The liquid resin was poured into the mould as shown in Figure 2 and after 7 days it was broken off using a Zwick Roell Z150 (Figure 3.) at the BME Laboratory of Strength of Materials.

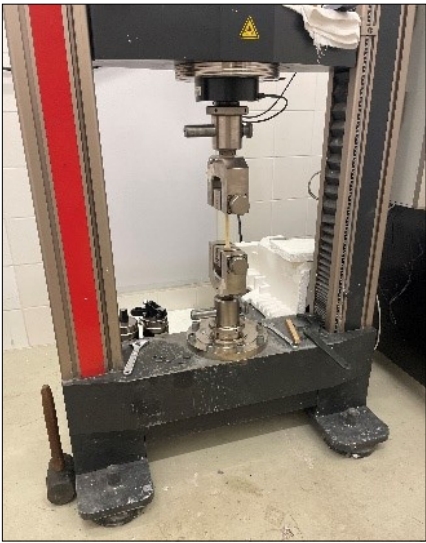
Fig. 3. Measurement of tensile strength of resin.

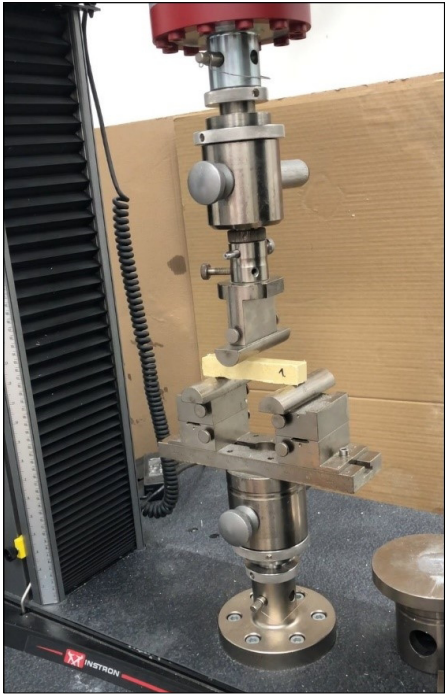
Fig. 8. Resin specimen tested for bending.

5 specimens with a geometry of 20×20×120 mm were made and loaded with a concentrated force at half the span.

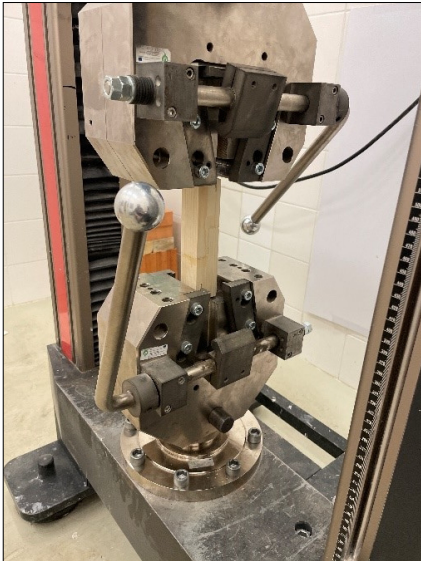
Fig. 12. Adhesion testing of resin applied on the sectional side of the wood.

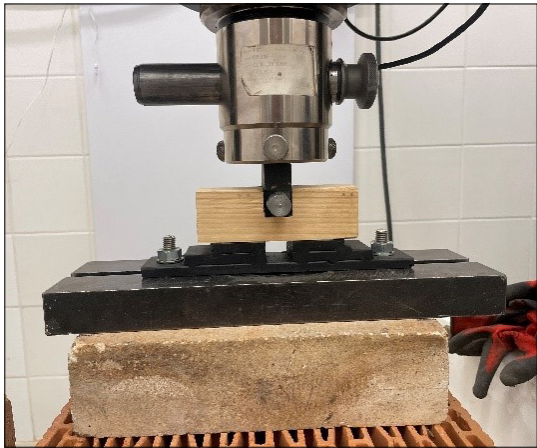
Fig. 18. Shear load test with weakening.

Fig. 19. Shear load test with weakening.

For the measurement, seven specimens of 40×40×120 mm, as used in the previous subsection, were prepared, on which a regular geometry cross-section reduction was applied in the shear-loaded section. In the loaded section, I removed a 20×20×40 mm section of the wood.

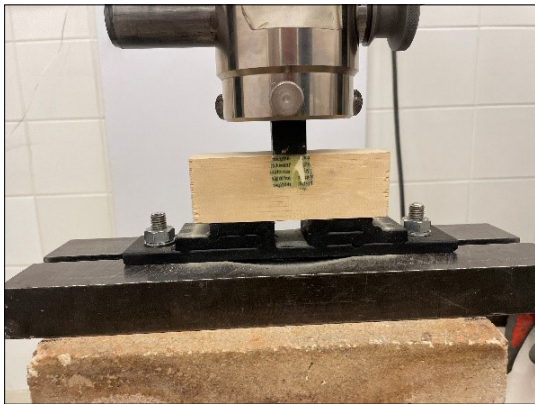
Fig.20. Shear test specimens supplemented with resins.

Fig. 21. Shear test specimens supplemented with resins.

Regular „weakened” specimens formed on the test specimens described in section 4.4.2 were filled with 3PHV60 resin and then these specimens were also broken while waiting for the resin to set.

The average value of the breaking forces for the resin-filled weakened specimens was 18626 N, while for the full cross-section intact wood specimens it was 16098 N.

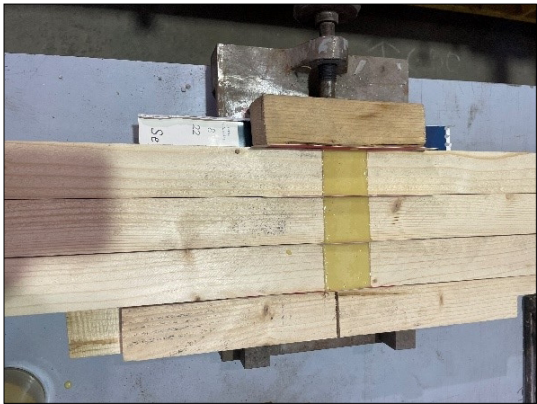
Fig. 25. Filling the weakened timber parts with epoxy resin.
