# **Examination of Damage Processes of Orthopaedic Orthosis**

#### Abstract

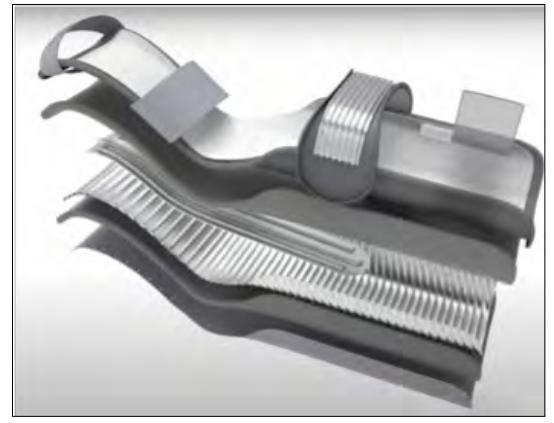
The product, illustrated in **Figure 1** was assembled from two types of plate (thickness 0.2 mm and 1.1 mm) with rivet fixation. The thinner plate provides the bending onto the arm and the thicker plate is responsible for the actual fixing. The X-ray microscope image immediately showed that the product was broken at the height of the wrist, across its entire width. On the device investigated, the distinct fracture only affected the thicker reinforcement plate, which was 1.1 mm thick. The thin corrugated aluminium, 0.2 mm thick plate, was only partially broken under load, or in the case of the stressed device, not broken at all (**Figure2**).

Figure 1. Exploded view of the layers of the palmar forearm. [5]

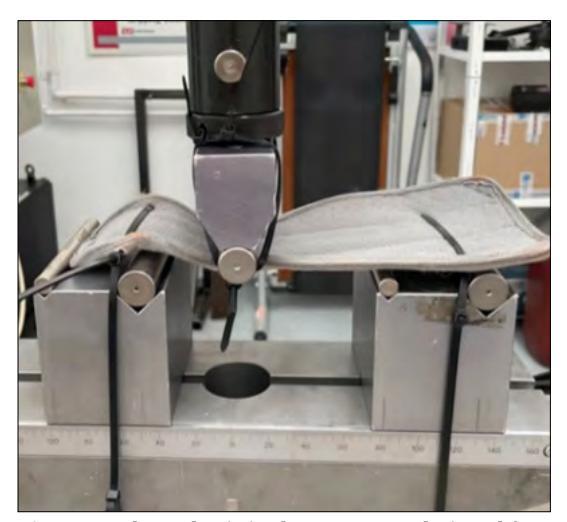
The fatigue test was performed using an IN-STRON 8872 servo-hydraulic loading machine provided by the BME Biomechanical Research Centre, with the orthosis held in the device as shown in **Figure 4**. The machine has a maximum load capacity of 20000 N and a crosshead movement speed range of 0.001–1000 mm/min.

The fatigue test was carried out in two parts. Firstly, I loaded the device without quick-clamping, at a test frequency of 1 Hz, with a position control of 10 mm, for a duration of approximately 400 cycles. This method proved not to be suitable. The second method was the quick-clamp clamping method (**Figure 4**). In this case, I subjected the rail to a real load for about 1500 cycles at a frequency of 2 Hz, also with 10 mm position control. The evaluation was performed only for the test simulating the real load using the second clamping method. MATLAB 2021 (The MathWork, Inc., Massachusetts, USA) software was used to calculate the results and generate the graphs.

Figure 4. The orthosis in the apparatus designed for fatigue testing.

compression head by 10 mm. This was the resistive force exerted by the orthosis on the machine. After this, a long stretch of maximum resistance value of about 80 N and then the breaking phase begins. Full breakage occurs at the 850th cycle. Here the resistance curve was set to the maximum value of 40 N. This resistance is only due to the tissues in the hybrid structure.
