# Laser Cutting of Austenitic Corrosion-Resisting Steels

Cutting of thick austenitic stainless steel sheets with a disc laser is not fully developed. In this research were investigated the surface of holes made on 3.25 mm thick stainless-steel cut with CO<sub>2</sub> laser beam and disk laser beam. Using optical microscope and electron microscope to examine the cutting surfaces, were observed that the cutting with the CO<sub>2</sub> laser result high quality surface (cutting 3,25 mm thick plates), but holes made with solid-state laser has microcracks on the inner side. These cracks are not acceptable to the customers.

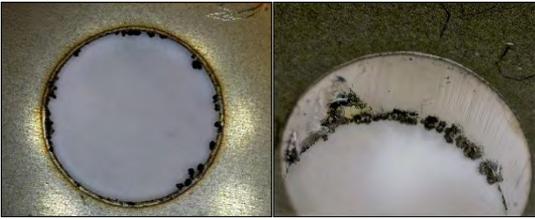
**Figure 1.** Adherent iron-oxide on the hole surface cut with CO<sub>2</sub> laser (∅ 6,2 hole)

The "adherent slag", as shown in [Figure 1](#). was typically visible on the surface of the hole cut with the CO<sub>2</sub> laser. For these cuts, were used the reference parameters previously accepted by the company, which are used to make existing parts. The metallographic pattern shows a uniform melting zone of about 40  $\mu\text{m}$  ([Figure 2.](#) ), which in some cases overflowed in approximately the same degree with the direction of cutting. In contrast, the disc laser-cut pieces did not exhibit this amount of adherent slag. At first glance, the edge of the cut is rough, but the roughness of its inner surface is

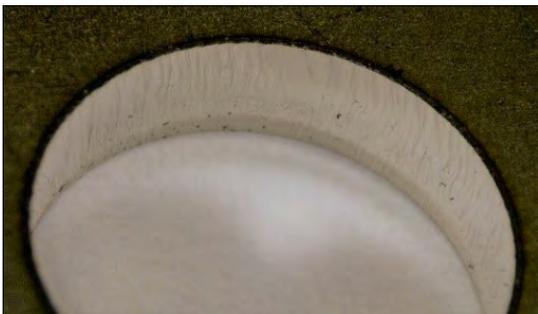
**Figure 4.** Hole made with Disk laser (∅ 13,6 hole)

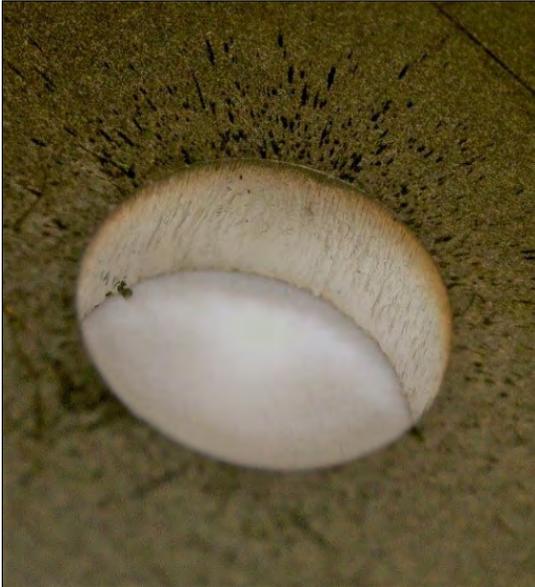
**Figure 6.** Spatter on the rim of the laser cut hole in the disc ( $\varnothing$  6,2 hole)

The cutting gas was not able to properly blow out the melt everywhere, causing spatter. The result of this shown in **Figures 6.** By changing the focus distance, a drastic reduction in hole surface quality can be seen in **Figure 7.** It can be seen that the roughness of the surface has increased, and spatter has appeared on both the hole edge and the surface of the sample.

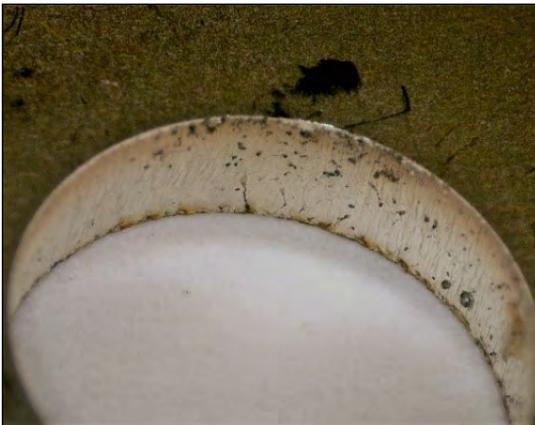
**Figure 7.** The cut made with disc laser, with changed focus distance from the centerline ( $\varnothing$  13,6 hole)
